NEW PRODUCT HIGHLIGHT | OCT2019

febi 109623

to fit:
Audi, Seat, Skoda, Volkswagen, Ford,
Various Models

Harness for engine

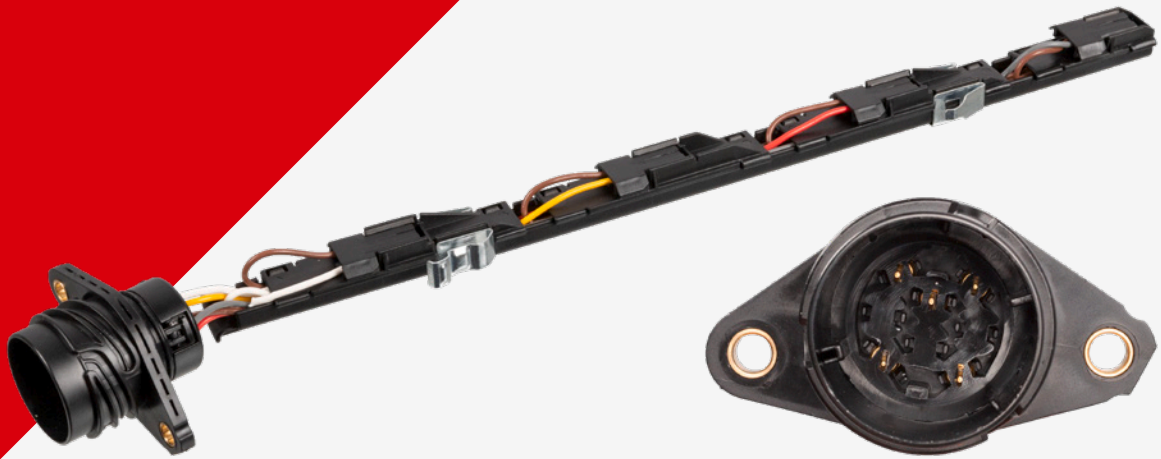
Unit injector wiring loom harness which is positioned in the cylinder head. This attaches to the engine wiring loom which is connected to the engine control unit, and controls the diesel injector solenoids.

Engine misfiring or not starting, due to a poor or broken connection of the wiring harness to the injectors, also deterioration of the wiring insulation causing a short or open circuit.

febi recommends when replacing the diesel injectors that the wiring harness is also replaced in order to reduce the risk of any connection problems. It is also recommended that the rocker cover gasket is replaced at the same time, as they often leak once disturbed.
